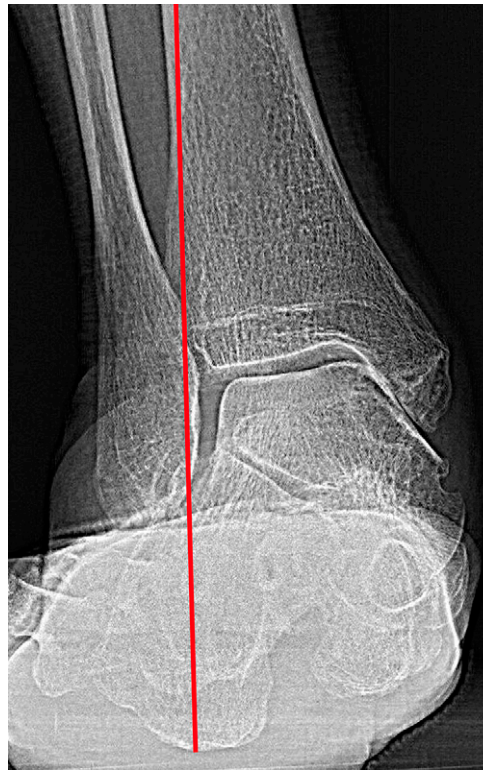
Fig. E-1A

Figs. E-1A and E-1B An eighty-two-year-old woman with knee osteoarthritis (Kellgren-Lawrence grade 4) and ankle osteoarthritis (modified Takakura stage 3A). This patient was not among the patients included in Part II of our study. **Fig. E-1A** A hip-to-calcaneus radiograph showing the mechanical axis of the lower limb (red line) from the center of the femoral head to the lowest point of the calcaneus, which differs from the traditional mechanical axis of the lower limb (i.e., the Mikulicz line, which is the line from the center of the femoral head to the center of the tibial plafond). **Fig. E-1B** The lower part of the hip-to-calcaneus radiograph shows the calcaneus in valgus position to compensate for the varus position of the knee and ankle. The subtalar joint is clearly shown.

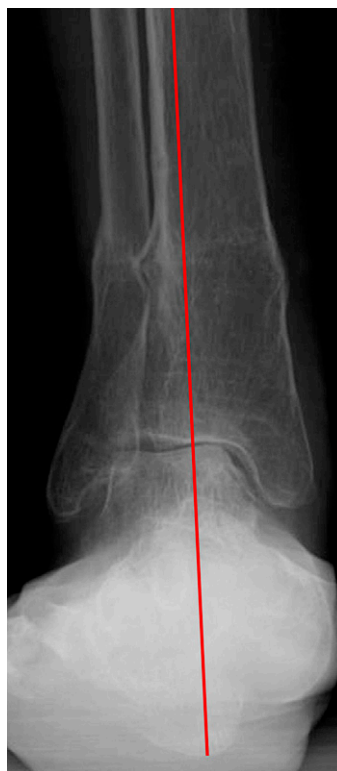
Fig. E-2A

Figs. E-2A and E-2B A sixty-six-year-old woman with varus-type osteoarthritis of the ankle. **Fig. E-2A** The lower part of the preoperative hip-to-calcaneus radiograph shows the mechanical axis (red line) passing through the medial edge of the plafond. **Fig. E-2B** The lower part of the hip-to-calcaneus radiograph, made four years postoperatively, showing that the arthritic change had progressed. The mechanical axis (red line) is also shown, and the AOFAS score was 60 points at the time of follow-up. In this patient, the axis did not move sufficiently to the lateral side of the ankle.
